經濟部104年度台日技術交流計畫

邀請日本專家來台指導「人工養灘之規畫執行與
離岸堤群佈設成效評估」成效檢討報告書

經濟部水利署第六河川局

中華民國104年11月

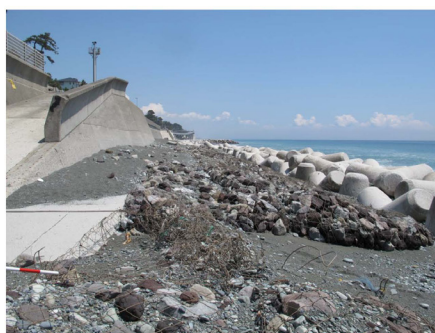
図-22 二宮海岸における破壊された鉄線電（2012年5月2日）
海岸が汚らしくかつ危険。

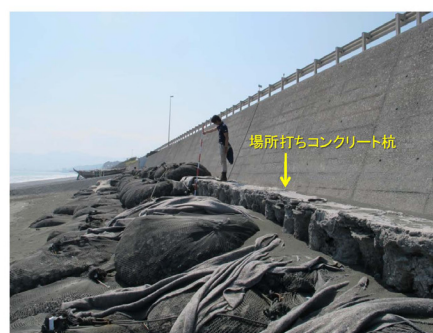
図-23 侵食されて露出した場所打ちコンクリート杭（2014年5月2日）
フィルターユニットは場所打ちコンクリート杭の頭部に並べられていたが、高波浪の作用により落下した。

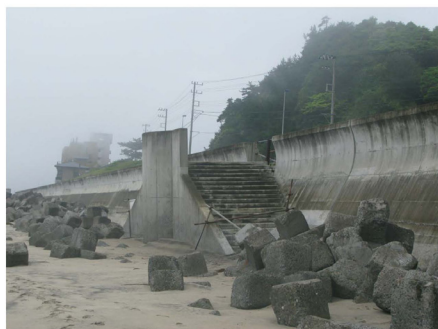
- Near the southern end of the coastline, beach erosion is still severe, and the stairs to the beach were damaged due to scouring.

Figure 5. Damaged stairs (July 9, 2009).

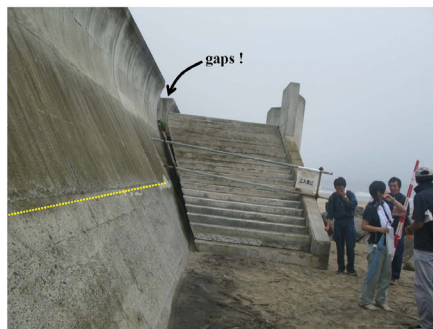
- The yellow line shows the previous ground level before erosion. The stairs were tilted.

Figure 6. Damaged stairs looking the front (July 9, 2009).

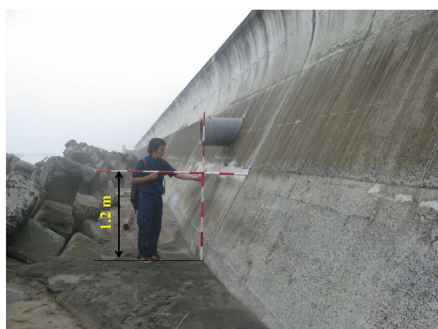
- The decrease in ground level reached 1.2 m.

Figure 7. Exposed seawall (July 9, 2009).

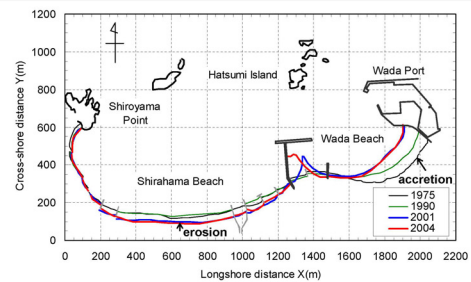
- The main cause is the extension of the breakwater of Wada Port, with an additional effect resulting from the construction of the detached breakwater.
- Because a groin was extended behind the detached breakwater, longshore sand transport, which moved freely eastward or westward without such a facility, was completely disrupted, resulting in the formation of two isolated pocket beaches.

Figure 18. Shoreline configuration and changes.

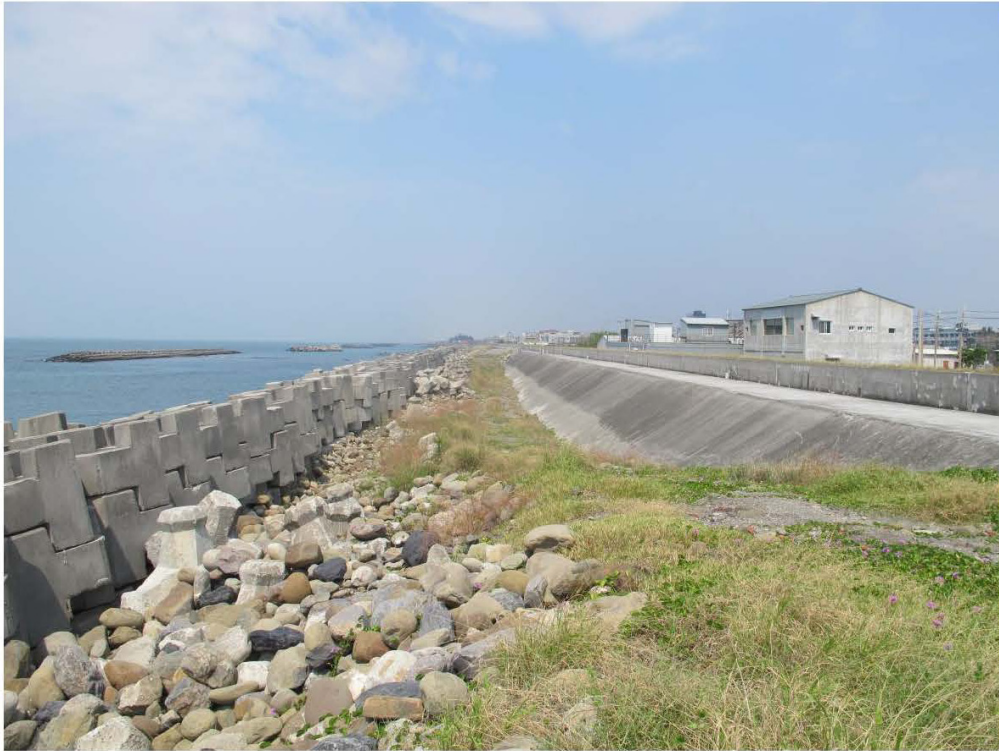
The south end of the study area is separated by the breakwater of Singda Port, which obstructs northward longshore sand transport, resulting in erosion north of the breakwater. Photo 1 shows the condition of the eroded coast, where concrete seawall extended straight along the coastline, and there was no foreshore in front of the seawall, and the coastline was protected by concrete armor units and large boulders against wave overtopping. In the offshore zone, detached breakwaters have been constructed. In this area, northward longshore sand transport, which was induced by the construction of the Anping Harbor breakwater, prevails and there is a fishing port breakwater upcoast, which blocks the sand supply from the upcoast. Thus, the sand volume in this area is gradually decreasing with the beach being eroded. Because the seawall and concrete armor units had only passively effected, their effect is limited to maintain the present shoreline. Even though detached breakwaters had been constructed, the recovery of sandy beach is impossible, because sand supply from the upcoast is entirely blocked by the fishing port breakwater. To recover sandy beach, beach nourishment using material with sand and gravel is needed, because the beach slope at this site has already steepened.

Photo 1. Southern coast covered with hard structures.

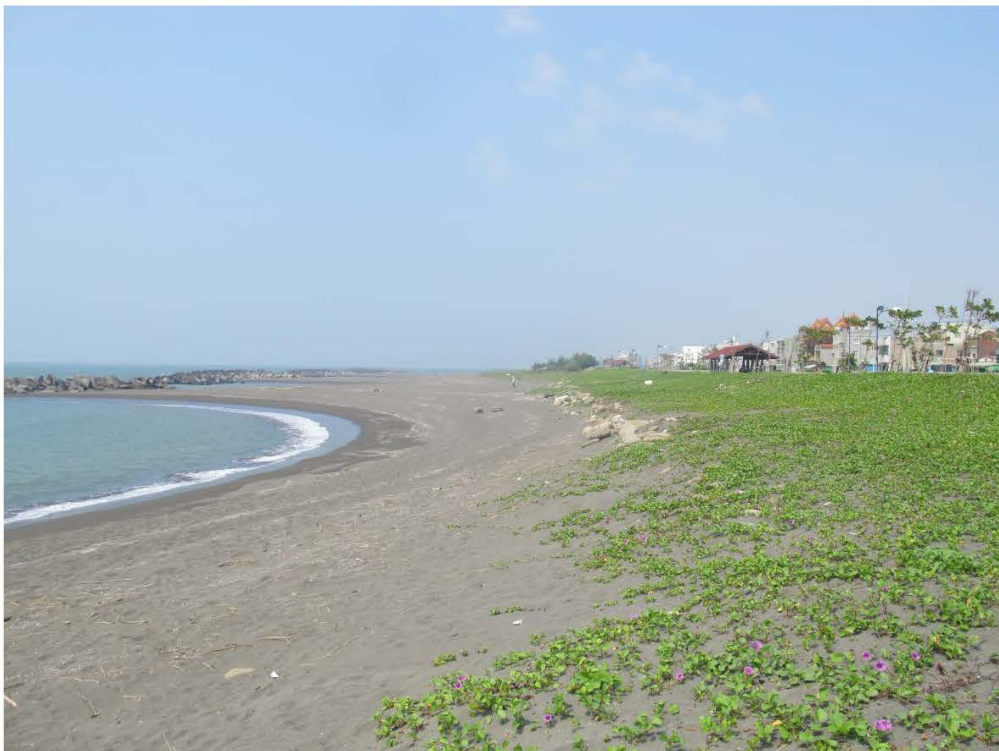
Photo 2 shows a scene of the beach between the detached breakwaters at site No. 2. Note that the backshore is widely covered with the vegetation zone. Coastal vegetation can grow only when the backshore is stable even in storm wave conditions, and thus the location shown in Photo 2 is found to be stable. The reason is such that detached breakwaters were constructed on both sides of this area. The sandy beach shown in Photo 2 was formed owing to the depositional effect of sand by these detached breakwaters, and sand was deposited even without beach nourishment. However, such sand is still gradually moving northward by northward longshore sand transport, implying that the sand volume in this area gradually decreases, resulting in the shoreline recession.

Photo 2. Cuspate foreland formed by depositional effect of detached breakwaters.

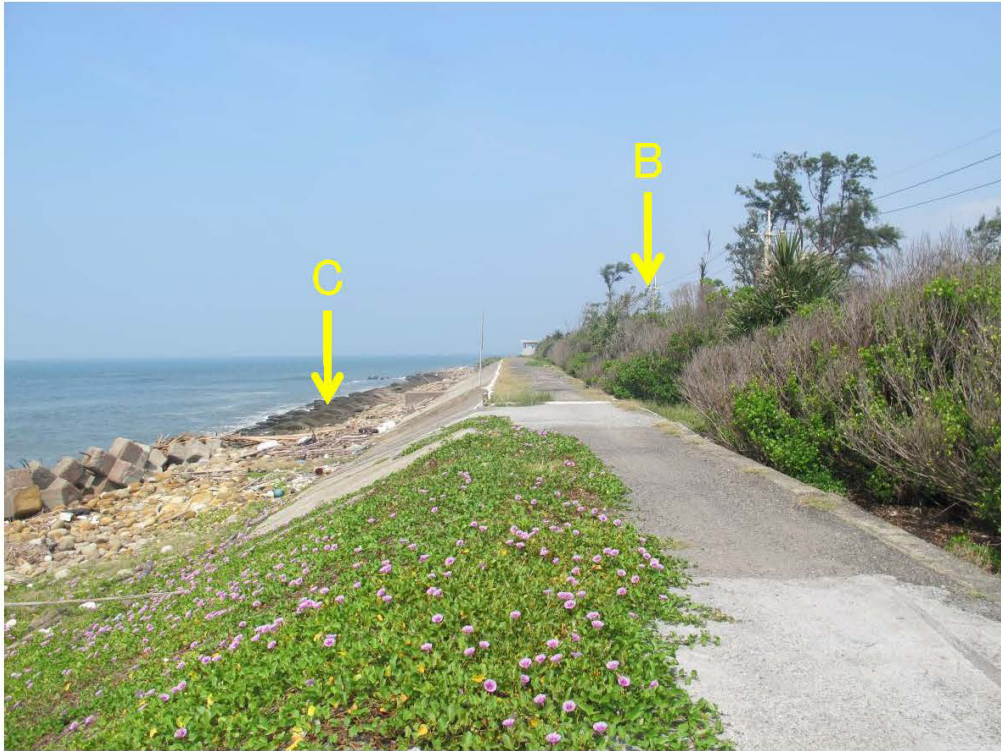
Although once there was a sandy beach immediately north of the Erren River, the beach was rapidly eroded owing to the discharge of sand by northward longshore sand transport. At present, no sandy foreshore exist in front of the seawall, as shown in Photo 7. Concrete blocks were placed along the shoreline with many drift woods. Photos 8 and 9 show the coastal condition immediately north of the river mouth. A coastal dike extends and the coastal vegetation grows along the landward side of the dike. When we carefully watch the front of the vegetation, as shown by arrow B in Photo 9, dead trees can be identified. This means that the elevation of the concrete armor units in front of

Photo 9. Coastal condition immediately north of the river mouth (Site 9).

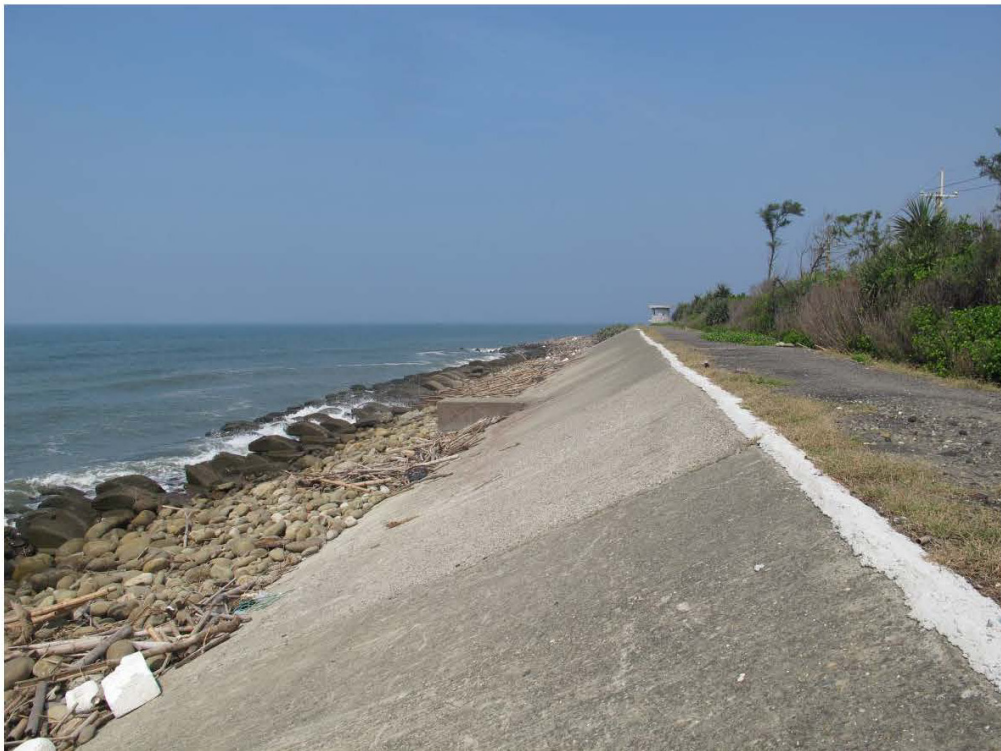
the vegetation is low enough to permit the wave overtopping. Photo 10 shows the detailed condition of the area, as shown by arrow C in Photo 9, where dead trees can be observed. In this area, the elevation of the area in front of the sloping revetment of the dike is supposed to be low and no vegetation grow, in contrast to the site No. 9, as shown in Photo 9. It is realized from this that the wave overtopping is severe at this site. The condition of trees grown in the backyard of the coastline becomes good index to judge the extent of the wave overtopping over the seawall.

Photo 10. Detailed condition of the area, as shown by arrow C in Photo 9.

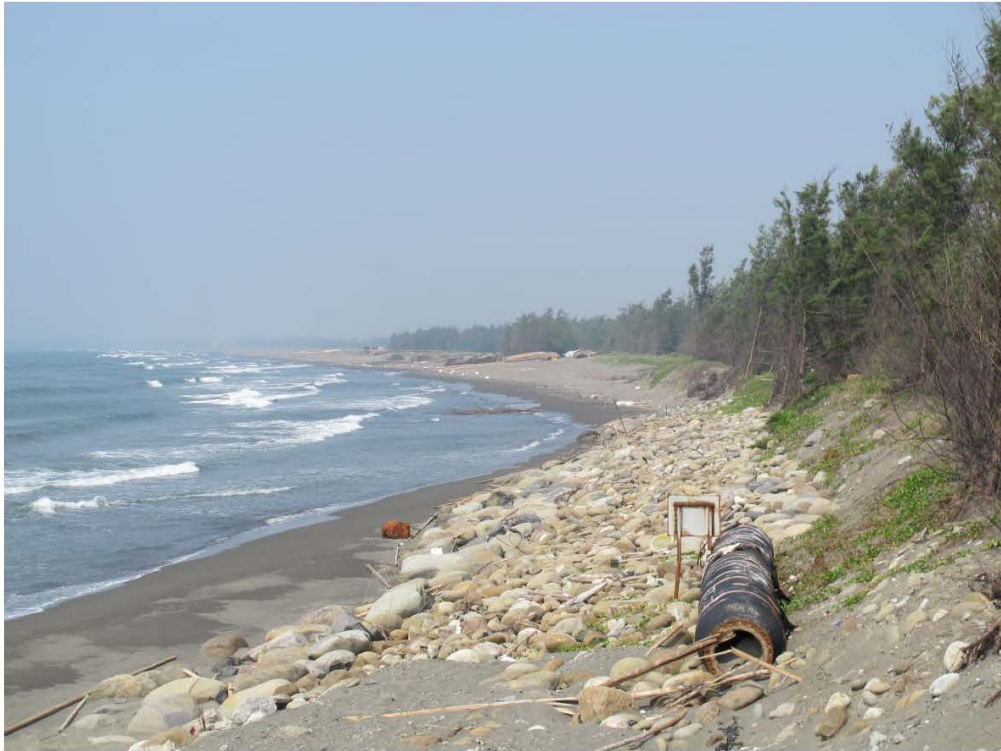
Photo 15. Eroded area downcoast of groins.

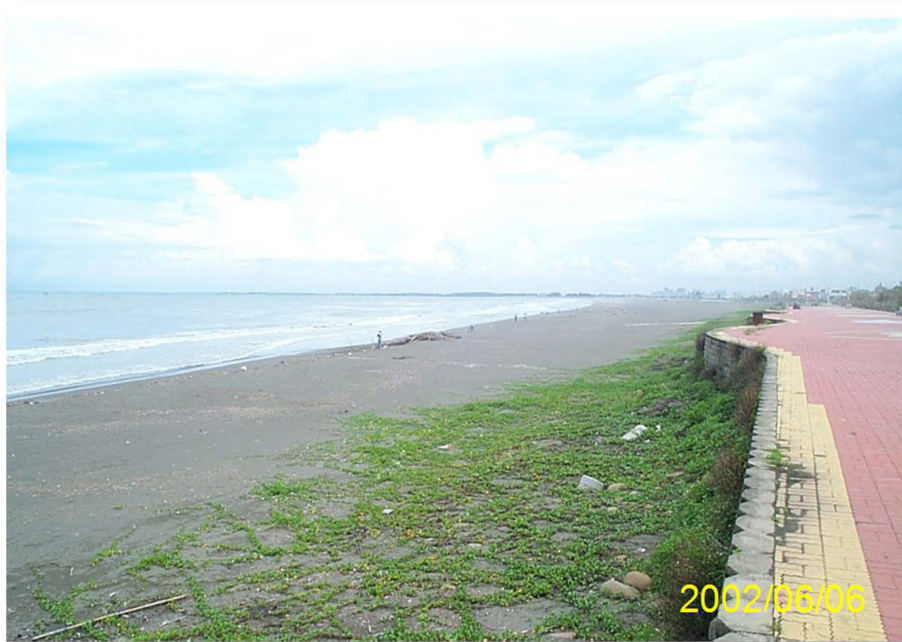
The shoreline on Golden Beach has retreated in recent years, and the seawall constructed far from the shoreline was severely damaged. This situation is clearly seen in site photographs. Figure 1 shows the photograph of the foreshore, seawall and walkway along the shoreline on Golden Beach, taken on June 6, 2002 before the erosion. A wide foreshore extended in 2002. Note that a vegetation zone extended in front of the seawall, implying that the backshore was stable against waves, because the ground elevation of the backshore was significantly high. Because of the existence of a wide foreshore with a high elevation, the seawall was supposed to be stable.

Fig. 1. Wide sandy beach before erosion on Golden Beach (June 6, 2002).

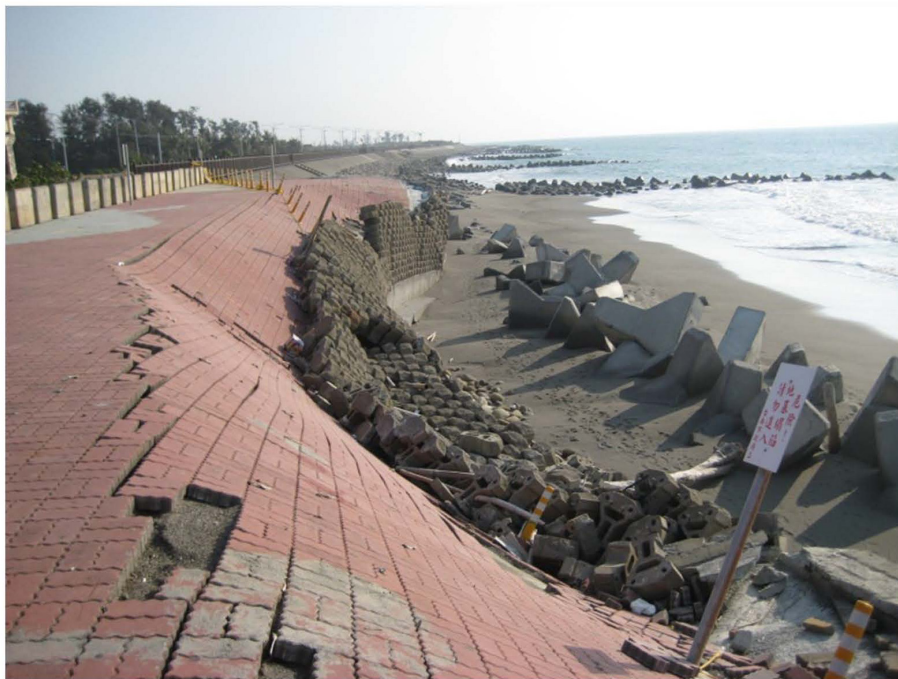
Figures 2 and 3 show the damaged seawall on Golden Beach on January 26, 2011, looking the south and north, respectively. The plane walkway fell down owing to the successive erosion, and concrete blocks were placed in front of the damaged seawall in Fig. 2, as well as the installation of groins. Also Fig. 3 shows the damaged walkway along the seawall, showing the discharge of sand underneath the walkway indirectly caused by the lowering of the elevation of the foreshore.

Fig. 2. Collapsed seawall and concrete armor units (January 26, 2011).

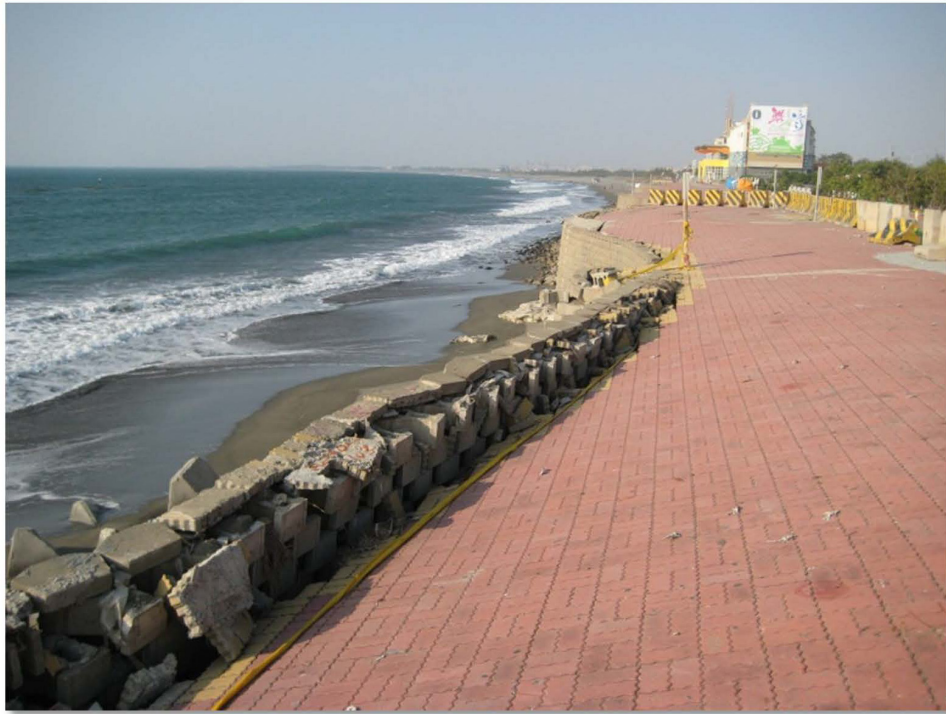
Fig. 3. Damaged walkway (January 26, 2011).

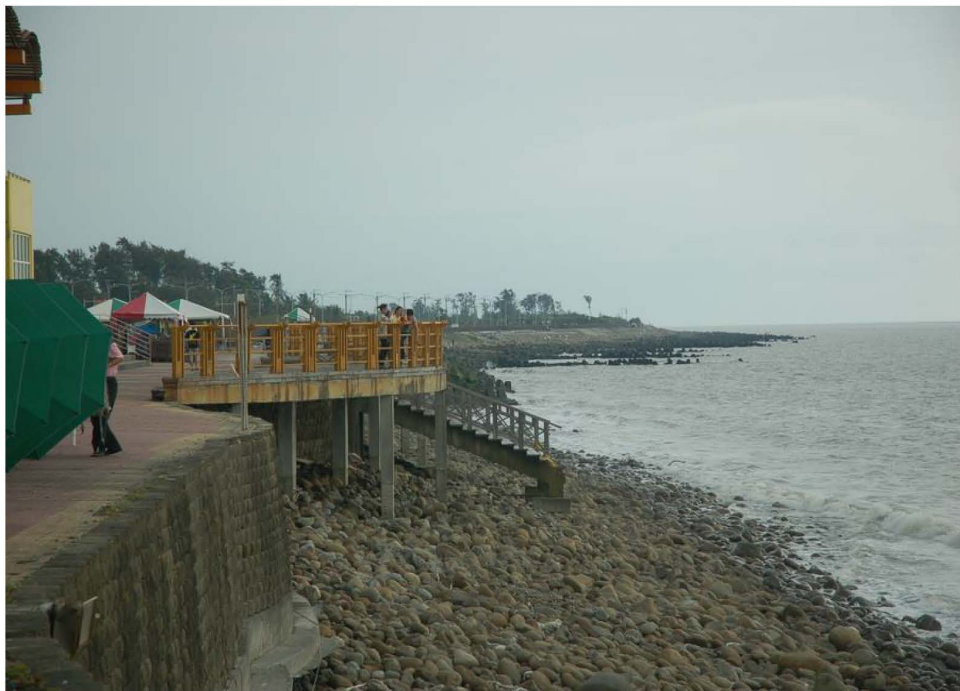
By September 1, 2012, all sandy beach disappeared with the exposure of gravel bed, as shown in Fig. 4. These beach changes were triggered by northward longshore sand transport induced by the wave-sheltering effect of the construction of the Anping Harbor breakwater. Sand volume has decreased by the imbalance in longshore sand transport, i.e., the outflow of sand from the area was larger than the inflow of sand. Therefore, even if a large amount of sand is to be nourished, the recovery of the previous wide sand beach is difficult, unless some structures which prevent sand from discharging northward from the site are installed.

Fig. 4. Severely eroded beach with exposure of gravel bed (September 1, 2012).
