經濟部104年度台日技術交流計畫

邀請日本專家來台指導「人工養灘之規畫執行與
離岸堤群佈設成效評估」成效檢討報告書

經濟部水利署第六河川局

中華民國104年11月

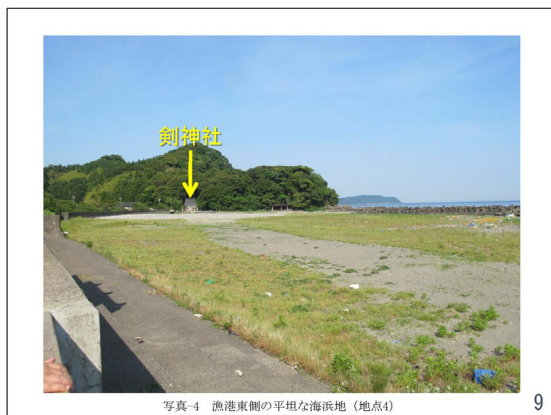
写真-4 漁港東側の平坦な海浜地（地点4）

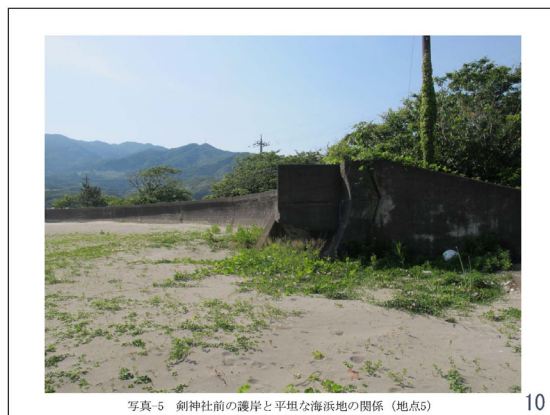
写真-5 剣神社前の護岸と平坦な海浜地の関係（地点5）

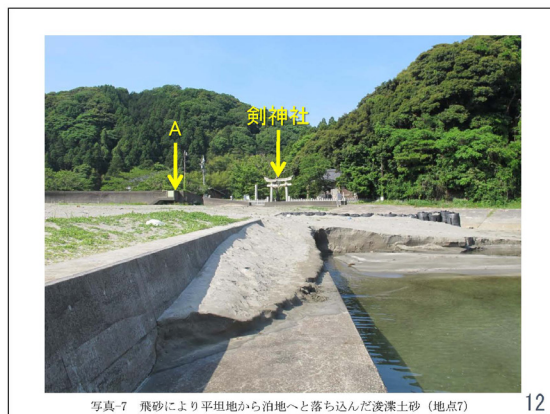
写真-7 飛砂により平坦地から泊地へと落ち込んだ浅瀬土砂（地点7）

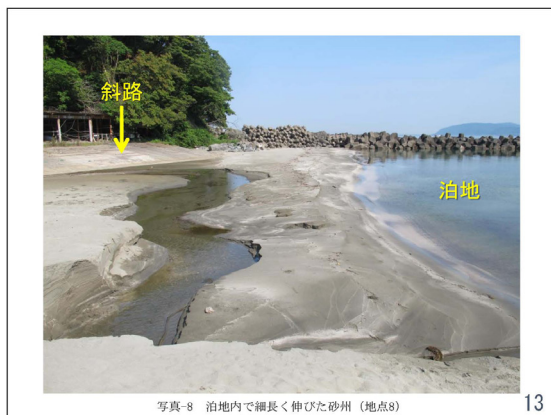
写真-8 泊地内で細長く伸びた砂州（地点8）

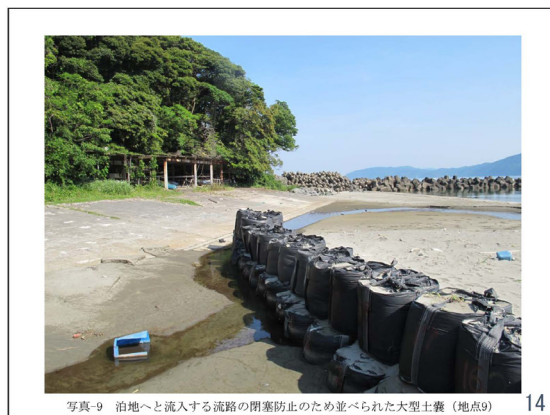
写真-9 泊地へと流入する流路の閉塞防止のため並べられた大型土嚢（地点9）

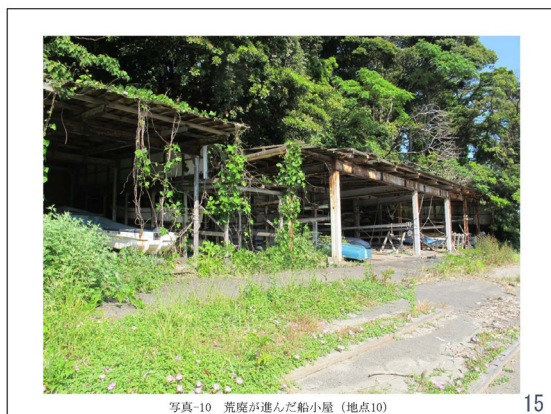
写真-10 荒廃が進んだ船小屋（地点10）

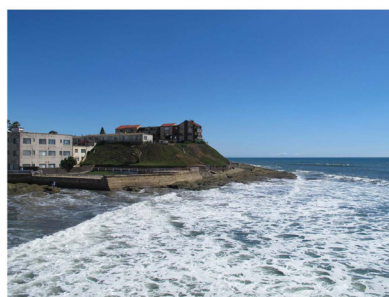
写真-6 Ocean Beach Pierから南側海岸を望む
Pierの南側はPoint Lomaへと続く岩石海岸が伸びる。写真の中央左には護岸があるが大部分の場所では防護施設は設置されていない。

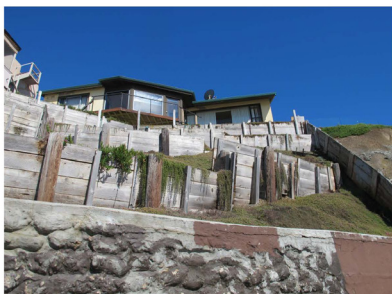
写真-7 Sea cliff上部の家屋の崩落を防止するためにproperty ownerが設置した土砂崩落防止施設
米国では崖地に住むのは個人の選択であり、公共機関が防護施設を設置する習慣はない。

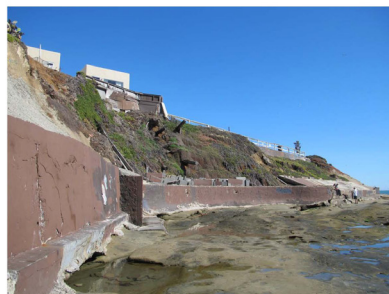
写真-8 海食台背後の護岸とその背後の崩落しつつある崖地

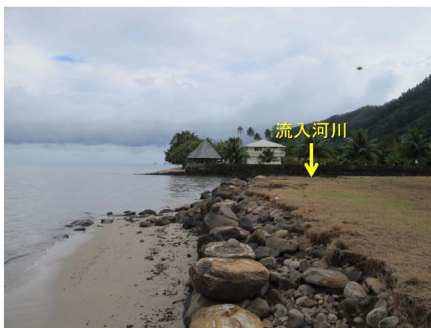
写真-1 流入河川の河口を北向きに望む(西岸の地点1)
高さ0.5m程度の石積み護岸が設置されていたが、背後の土砂の一部が流出していた。

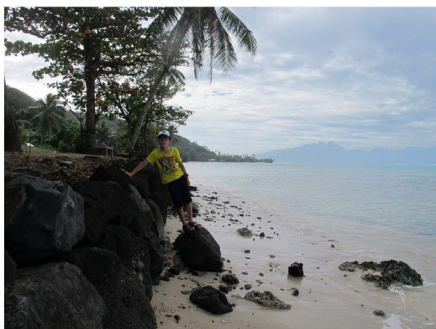
写真-5 海岸道路を守る高さ約1.5mの石積み護岸（南端の地点5）

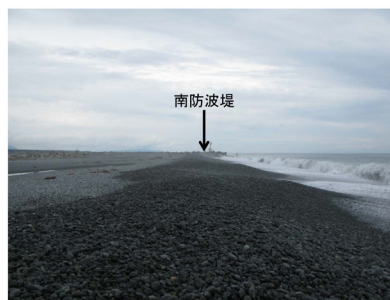
写真-1 大井川河口を背にして南防波堤を望む
高い葎が南防波堤まで直線状に伸びる。

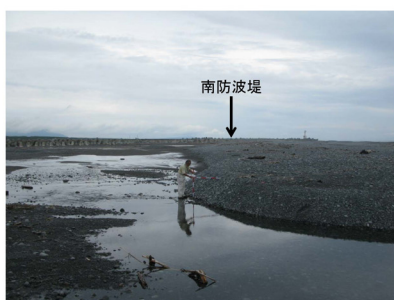
写真-2 掘削されてきた平坦面を海側から塞いで堆積した砂礫
砂礫の堆積域の陸側端には安息勾配の急斜面が形成

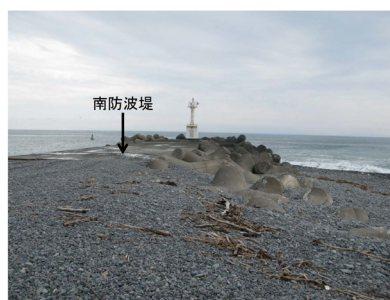
写真-3 南防波堤先端の天端を埋めた砂礫

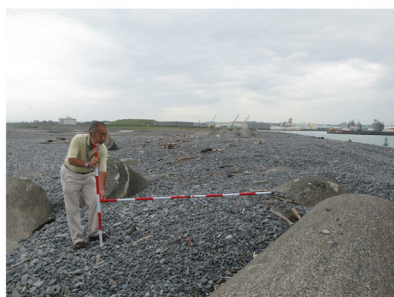
写真-4 南防波堤の天端周辺での砂礫の勾配1/4

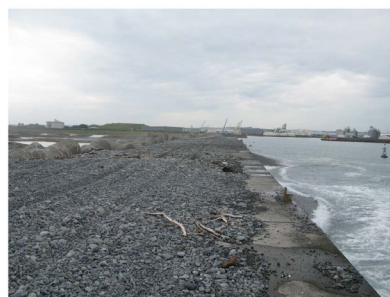
写真-5 南防波堤の天端を埋める礫

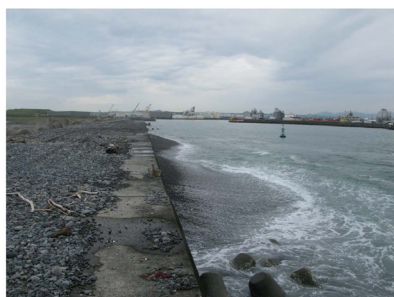
写真-6 南防波堤の内側に形成されていた砂州
ここに堆積した砂礫の一部は防波堤の天端を越えたもの、また一部は南防波堤の先端を回り込んで波により押し込まれたもの、いずれにしても南防波堤の南側の砂礫は満砂状態まで堆積が進んでいる。

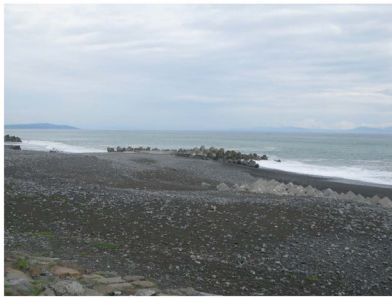
写真-12 現地試験の行われていた幅広突堤背後での堆砂状況

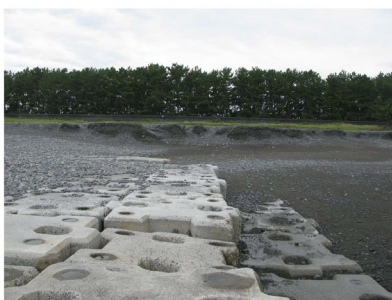
写真-14 幅広突堤の背後地にできた浜崖

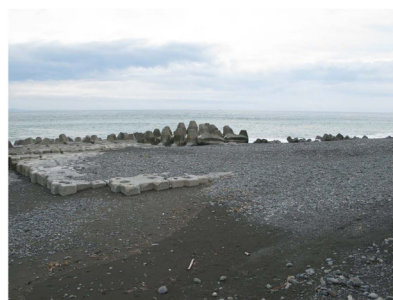
写真-15 幅広突堤上での礫の堆積状況

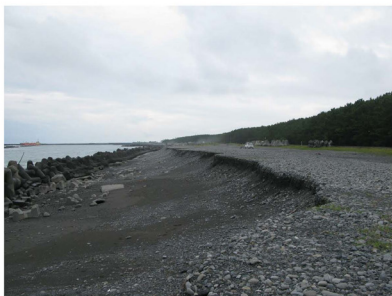
写真-8 盛り土養浜区間に残された平坦面と浜崖

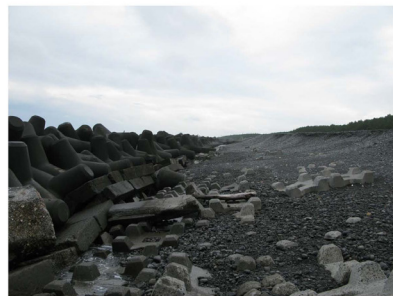
写真-9 波の侵食作用で削り取られた盛り土

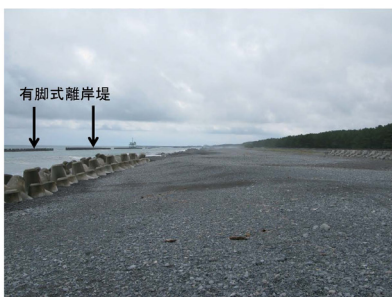
写真-10 有脚式離岸堤周辺の海浜状況（南向き）

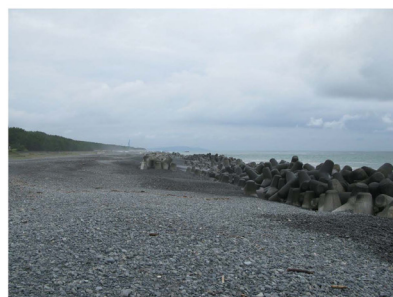
写真-11 有脚式離岸堤周辺の海浜状況（北向き）

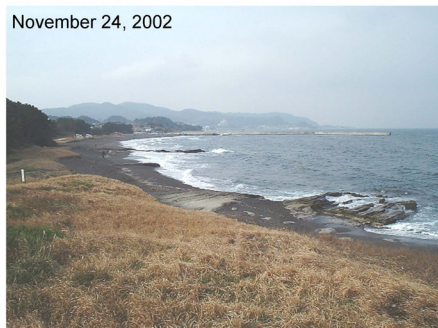
- A sand dune was eroded and rocks, which were raised during the Kanto Earthquake in 1923, were exposed.

Figure 11. Nearby coast east of Shimobara fishing port (November 24, 2004).

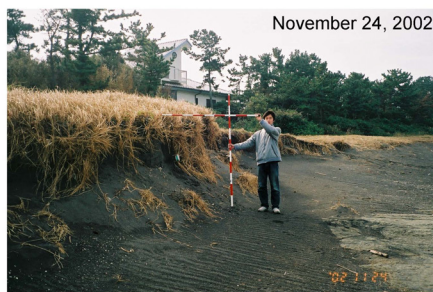
- Note the exposure of many roots of coastal vegetations, implying the disappearance of a sand dune covered by vegetations.

Figure 12. Scarp with 1.6 m height formed in erosion zone (November 24, 2002)

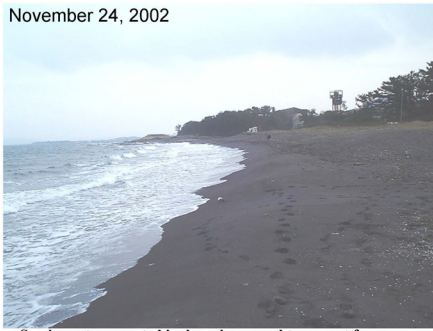
- Sand was transported by longshore sand transport from outside to inside the wave shelter zone.

Figure 13. Sand accumulation and berm formation immediately east of the fishing port (November 24, 2002).

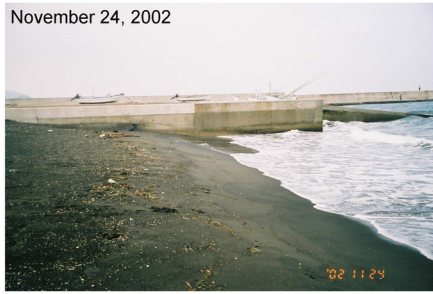
- A berm was formed owing to successive sand deposition at this site.

Figure 14. Seawall of Shimobara fishing port (November 24, 2002).

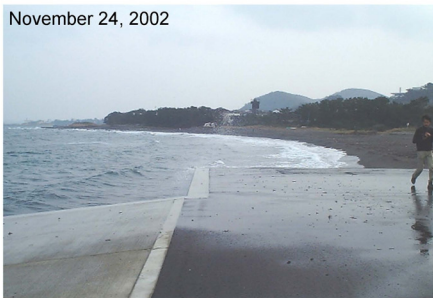
Figure 15. Wave overtopping to the corner of the seawall (November 24, 2002).

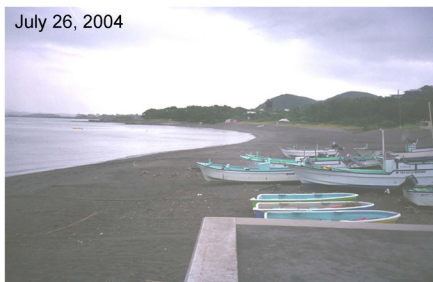
- The same location as that in Figure 15.

Figure 16. Markedly advanced shoreline owing to wave-sheltering effect of extended breakwater (July 26, 2004).

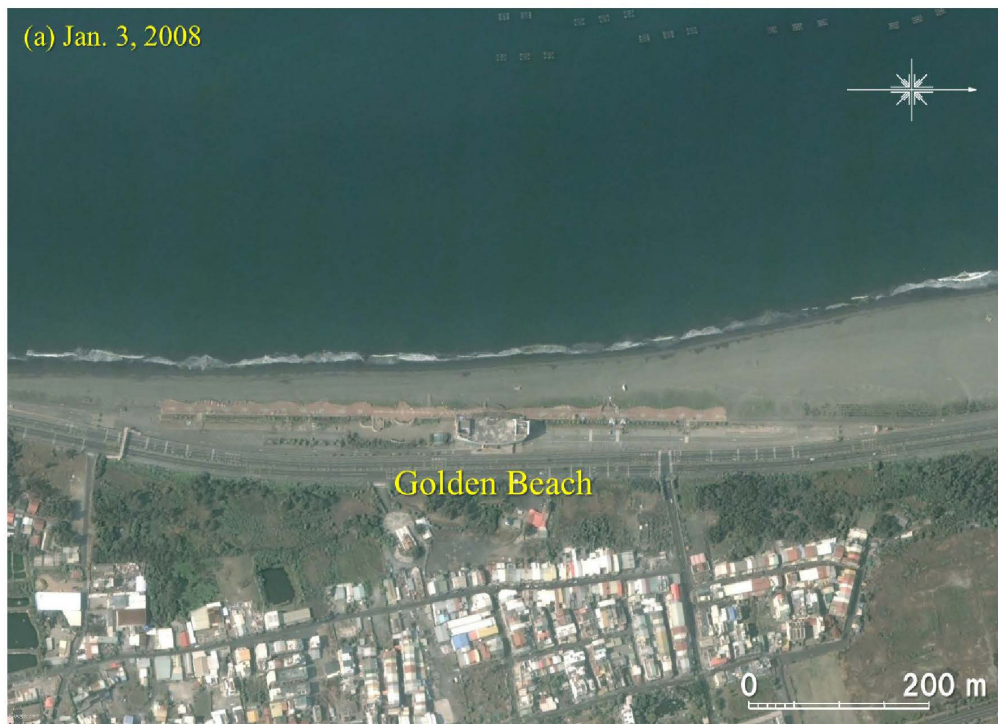
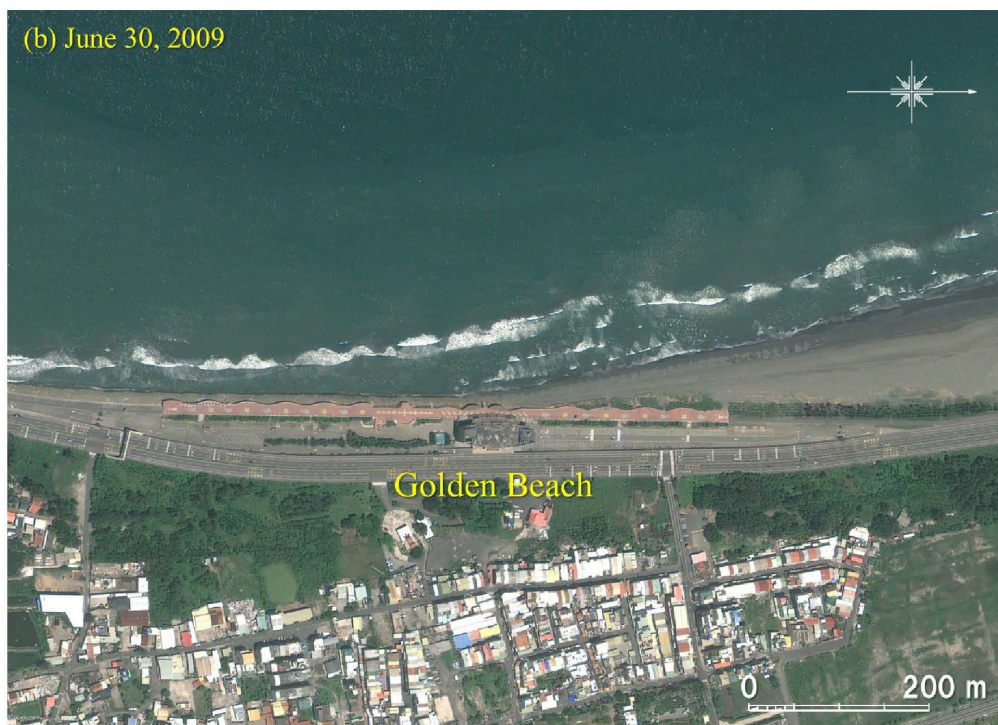
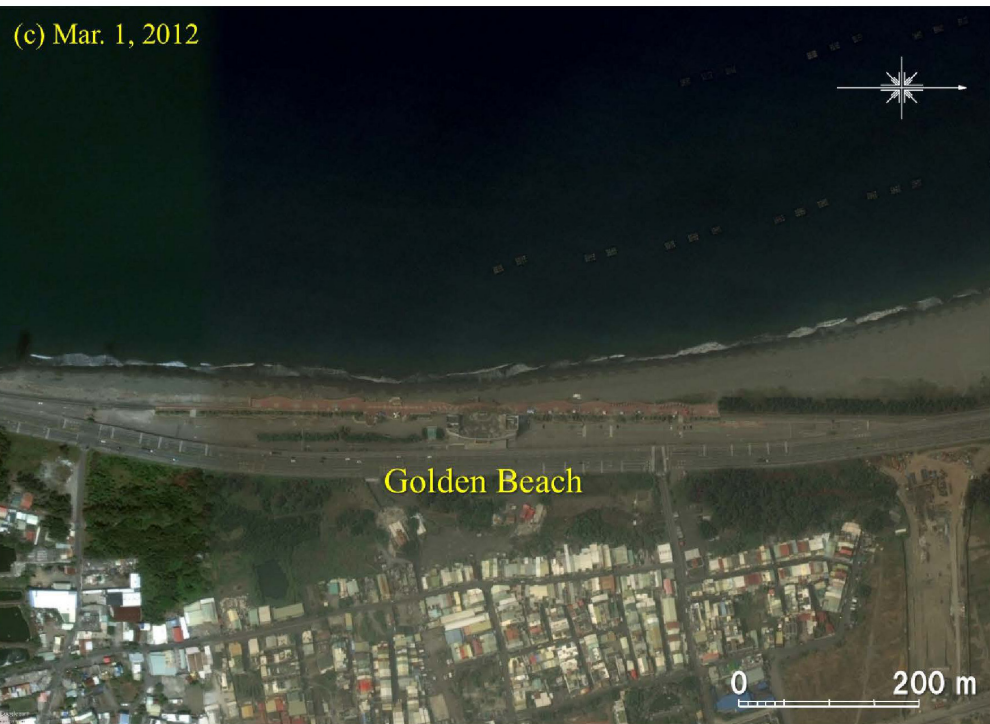
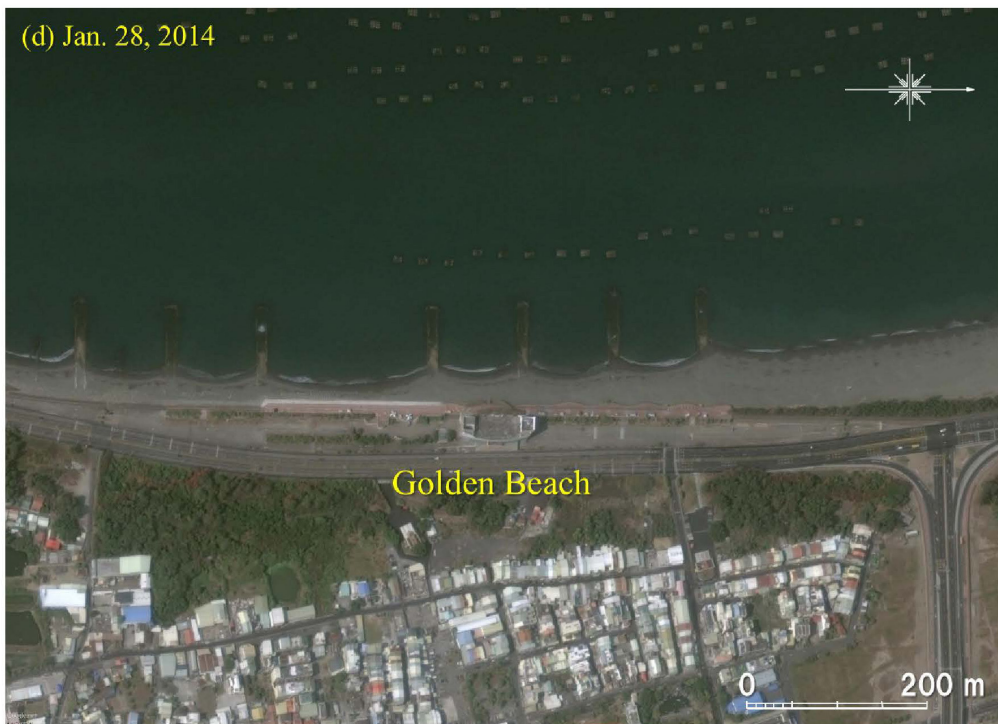
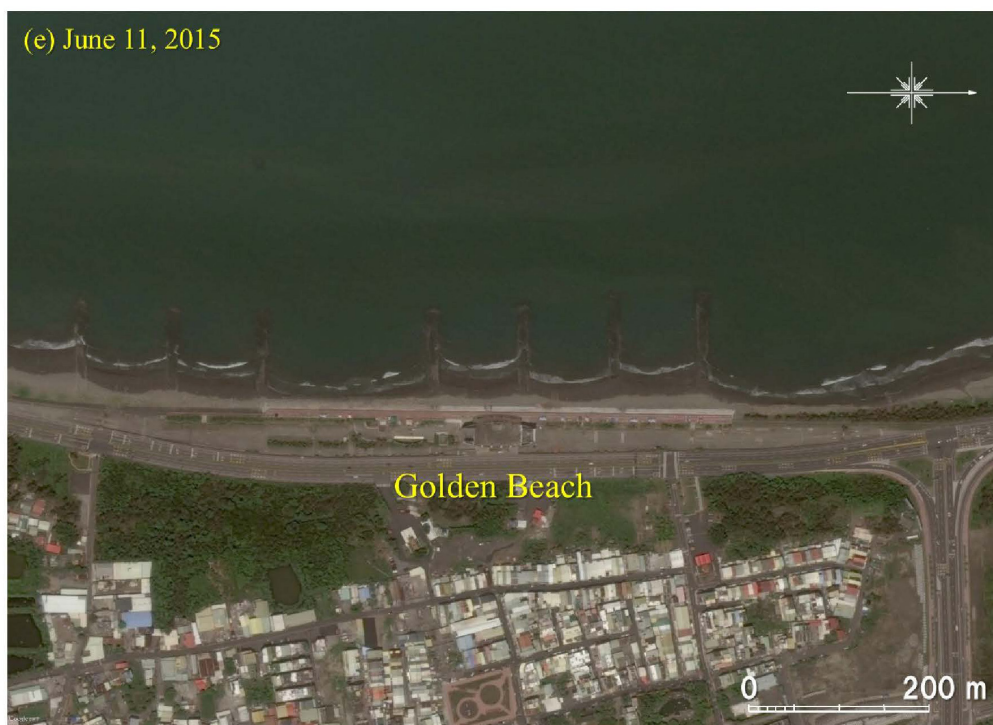
Fig. 2. Sequence of shoreline changes on Golden Beach.

On Golden Beach, there was a beautiful sandy beach composed of fine sand in front of the seawall in 2008, but the sandy beach was severely eroded, and only a narrow foreshore is left at present. Figure 2 show the sequence of beach erosion on Golden Beach: (a) January 3, 2008, (b) June 30, 2009, (c) March 1, 2012, (d) January 28, 2014, and (e) June 11, 2015. Although a natural sandy beach extended in January 3, 2008, beach was rapidly eroded, and the shoreline was protected by groins. Photo 11 shows the coastal dike constructed at Golden Beach and a narrow foreshore in front of the dike. Up to now, six groins have been constructed to control northward longshore sand transport. Photo 12 shows the groin at the downdrift (north) end of the beach. The bamboos placed on the foreshore are tool for aquaculture of the oysters. Photo 13 shows the enlarged view of the groin at north end of the beach. The concrete blocks composed of the groin subsided up to such a level that the crown of the groin is invisible, as shown in arrow D. Longshore sand transport is the largest near the shoreline so that this shows that large part of longshore sand transport can pass this groin. Photo 14 shows the downcoast of the same groin. There is a difference in the shoreline position between both sides of the groin, and the shoreline on the north side retreats, suggesting that this groin has still an ability blocking part of the longshore sand transport, although the effect of blocking longshore sand transport is low.

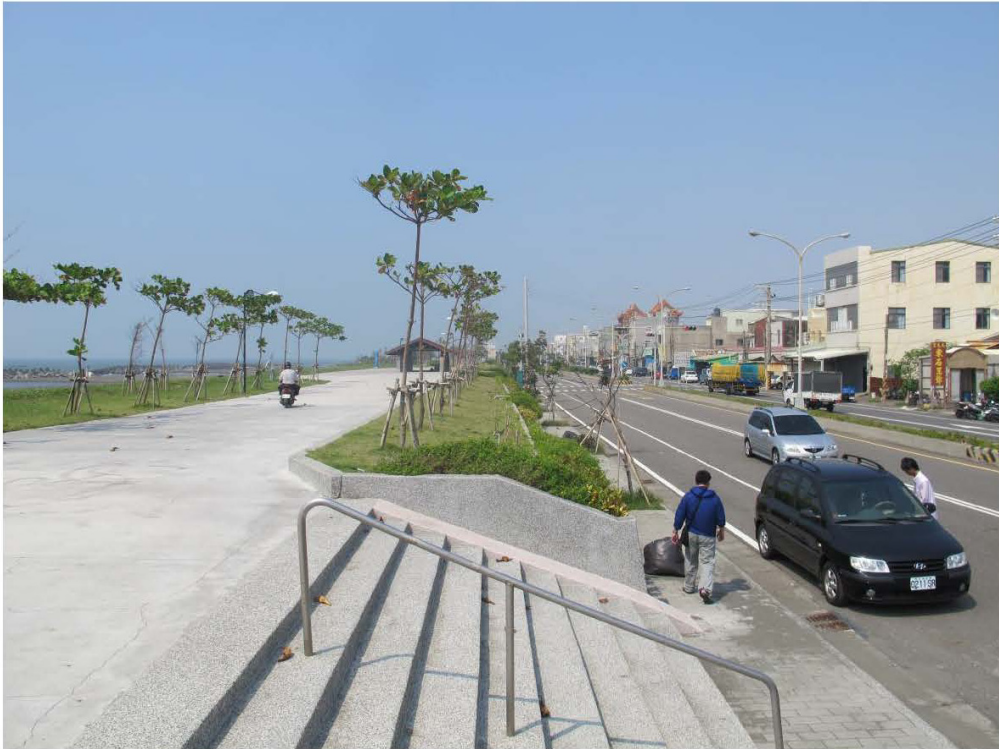
Immediately south of the Erren River, coastal road extends along the coastline and the area inland of this road is crowded with houses, as shown in Photo 3. To protect the densely-populated area, a super dike with a concrete pavement on top of the coastal dike has been constructed. Beyond this coastal dike, a straight walkway extended along the seaward part of the coastal dike with a fence, as shown in Photo 4. However, seaward of this fence, there was no sandy beach and the coastline was entirely covered with large boulders and concrete armor units, as shown in Photo 5. On the south side of the location shown in Photo 5, the seawall was directly exposed to sea waves. Under such a condition, normally wave overtopping over the seawall becomes severe. Such condition can be observed by the presence of dead trees on the bank, as shown by arrow A in Photo 6. Similarly, if we walk along the coastline and watch the vegetation, we can get the information of the severity of the wave overtopping over the seawall.

Photo 3. Super dike with concrete crown to protect coastal road and houses.

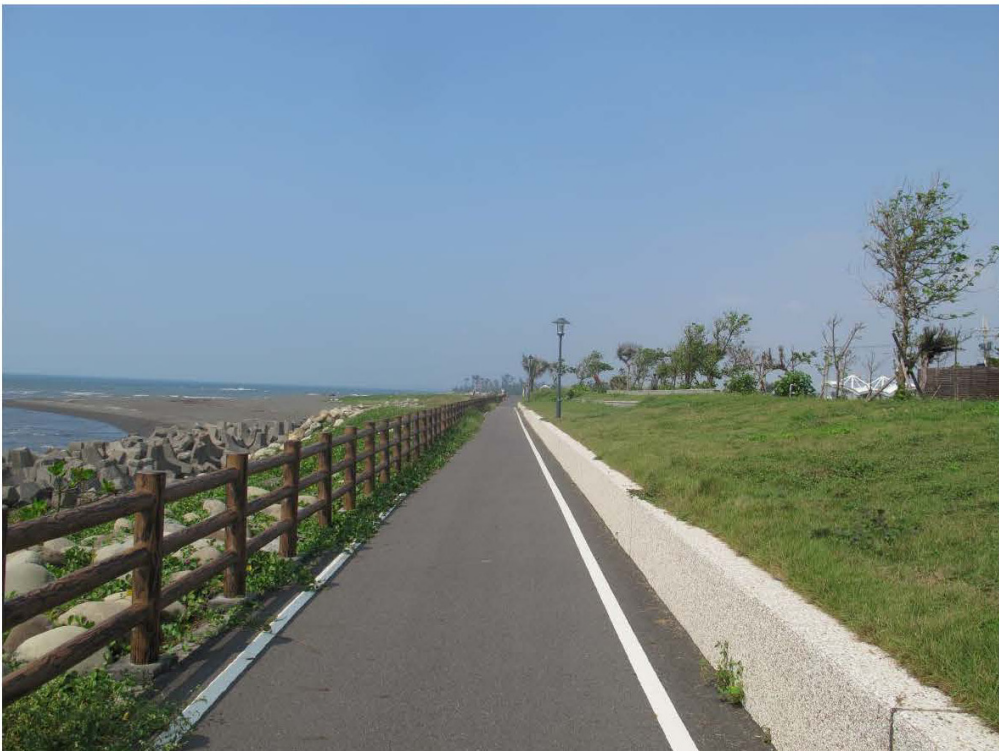
Photo 4. Walkway along coastal dike.

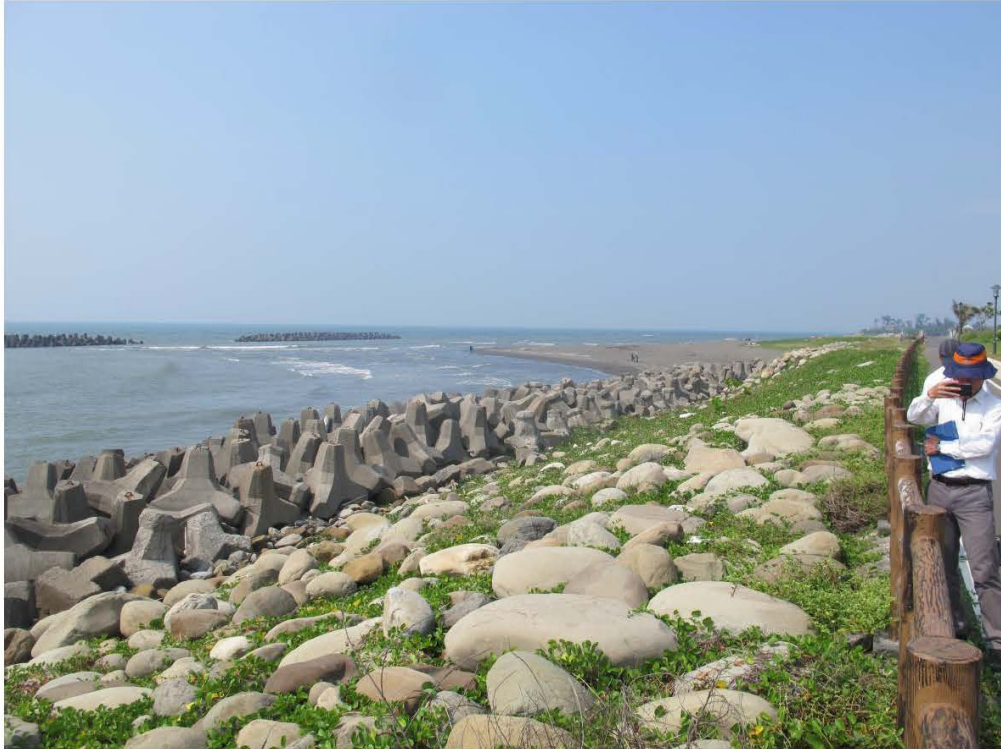
On the other hand, a wide sandy beach extended behind the detached breakwater located on the left side of the Erren River, as shown in Photo 5. The cusped foreland behind the detached breakwaters was once formed owing to the depositional effect of the detached breakwater, but now the sand volume of the cusped foreland is gradually decreasing owing to the discharge of sand by northward longshore sand transport.

Photo 5. Large boulders and concrete blocks to protect coastline.

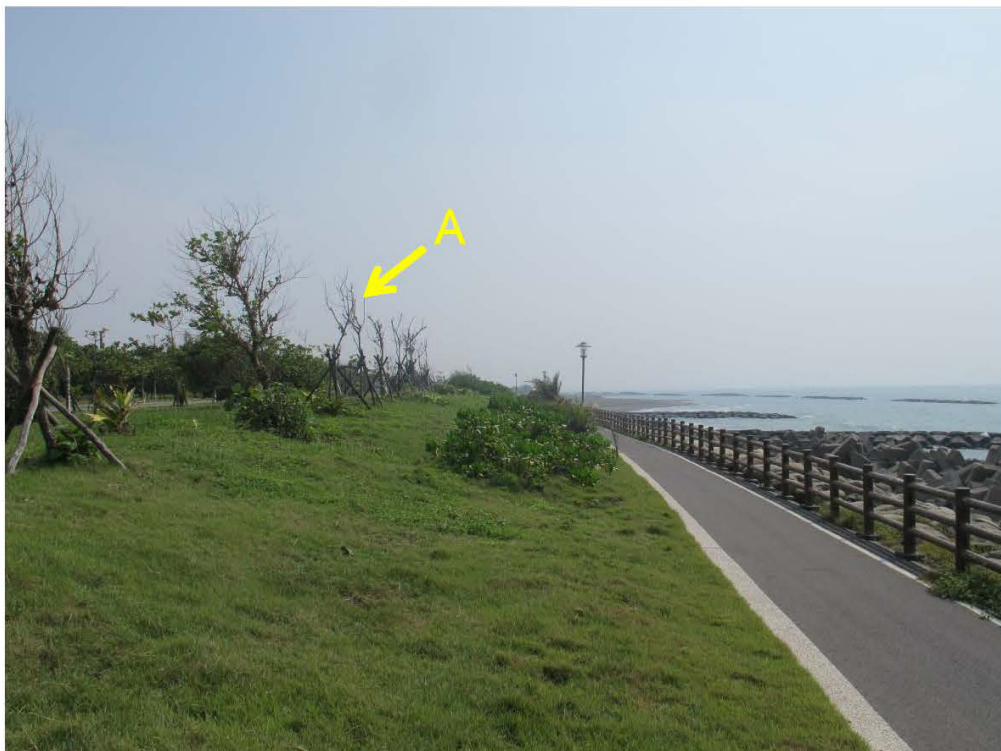
Photo 6. Coastal dike with gentle slope and vegetation.

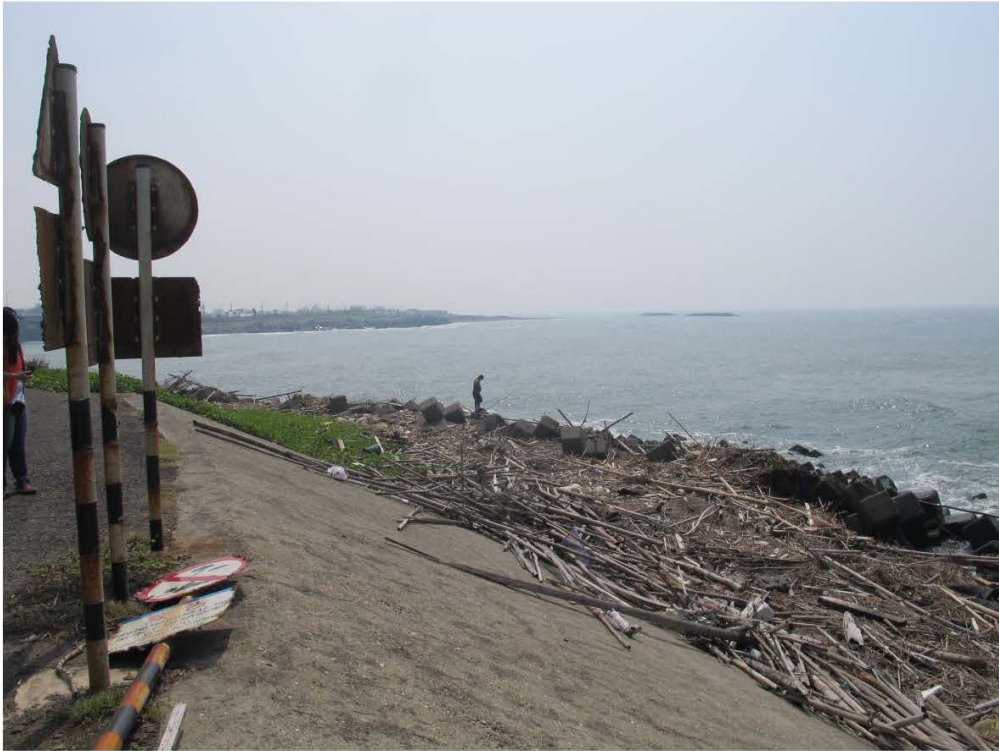
Although once there was a sandy beach immediately north of the Erren River, the beach was rapidly eroded owing to the discharge of sand by northward longshore sand transport. At present, no sandy foreshore exist in front of the seawall, as shown in Photo 7. Concrete blocks were placed along the shoreline with many drift woods. Photos 8 and 9 show the coastal condition immediately north of the river mouth. A coastal dike extends and the coastal vegetation grows along the landward side of the dike. When we carefully watch the front of the vegetation, as shown by arrow B in Photo 9, dead trees can be identified. This means that the elevation of the concrete armor units in front of

Photo 7. Protected coastline at Erren River mouth.

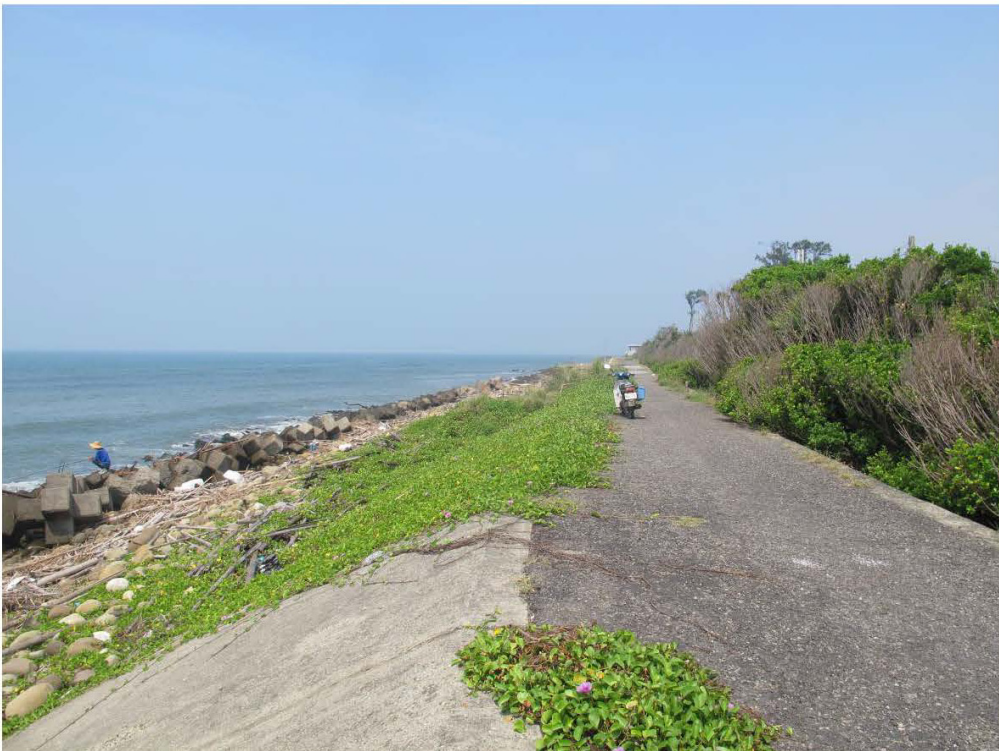
Photo 8. Coastal condition immediately north of the river mouth (Site 8).

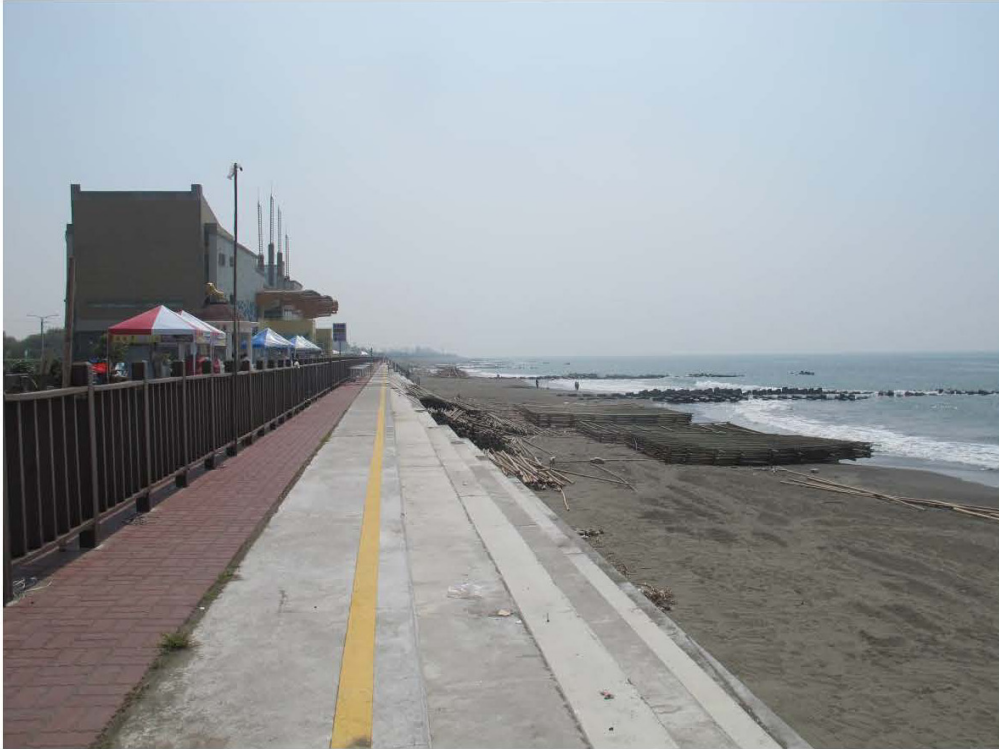
Photo 11. Coastal dike constructed at Golden Beach.

- (3) The foreshore width is narrow on Golden Beach because of successive erosion. In this area, the shoreline has a concave shape and groins have already constructed as well as the beach nourishment. Without structures such as groins or detached breakwaters, nourishment fine sand should be discharged again, because the wave-sheltering effect continues eternally. It is recommended that additional groin(s) is (are) constructed downcoast (north) of Golden Beach for the entire shoreline between Golden Beach and Anping Harbor to be stable, and then beach nourishment using sand deposited immediately south of Anping Harbor is considered.

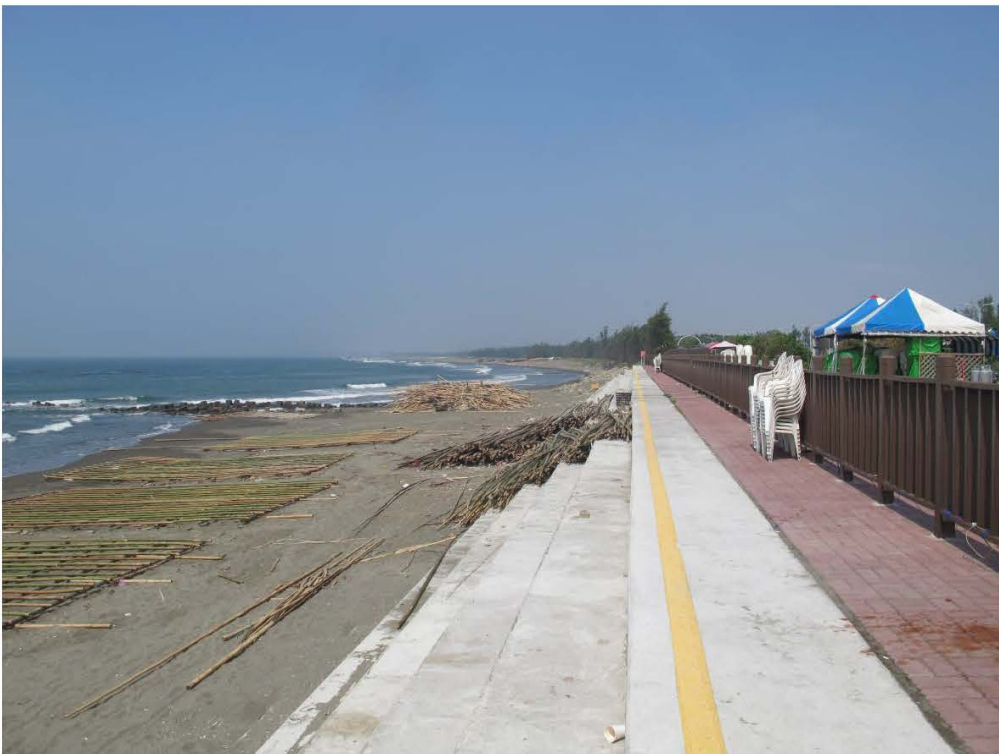
Photo 12. Groin at downdrift (north) end of beach.

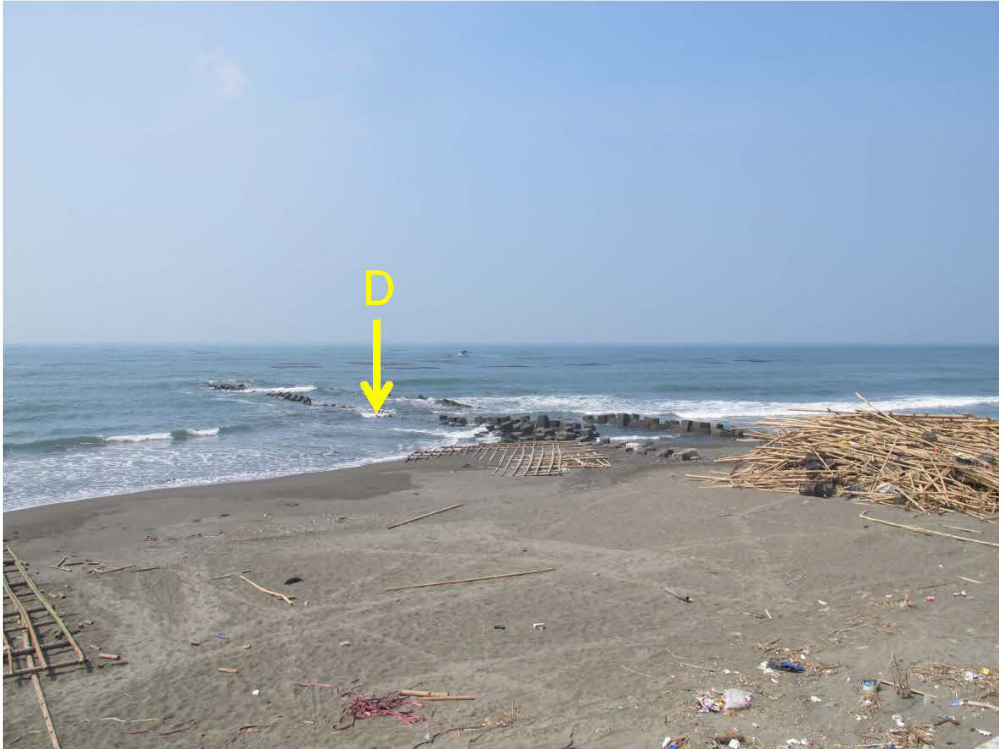
Photo 13. Enlarged view of groin at north end of beach.

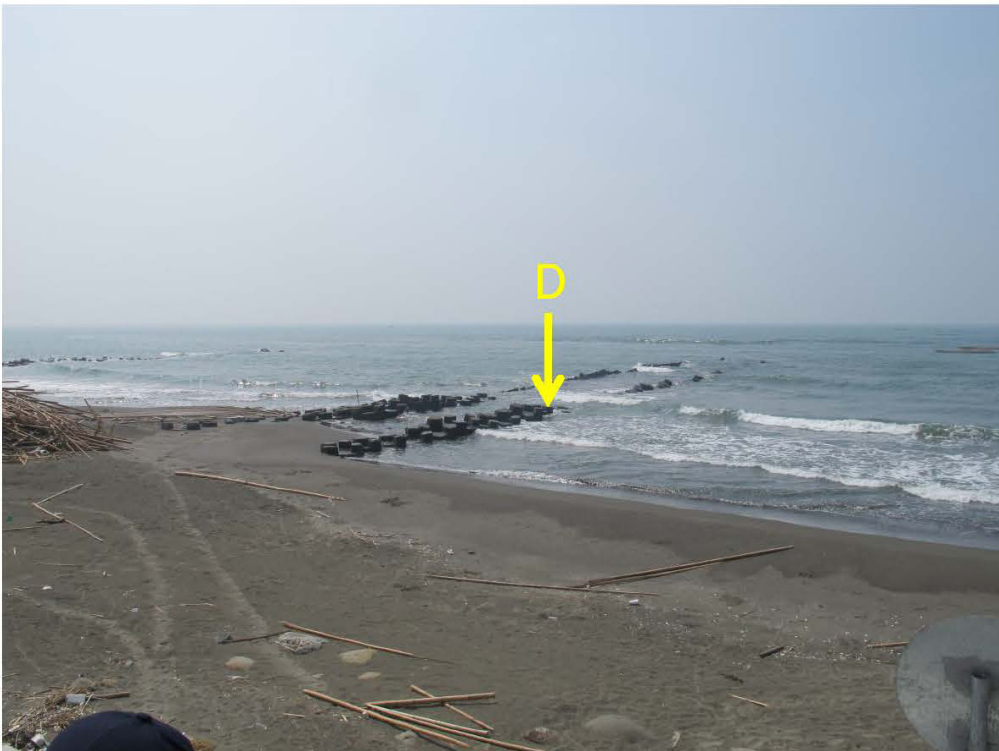
Photo 14. Immediately downcoast of groin.

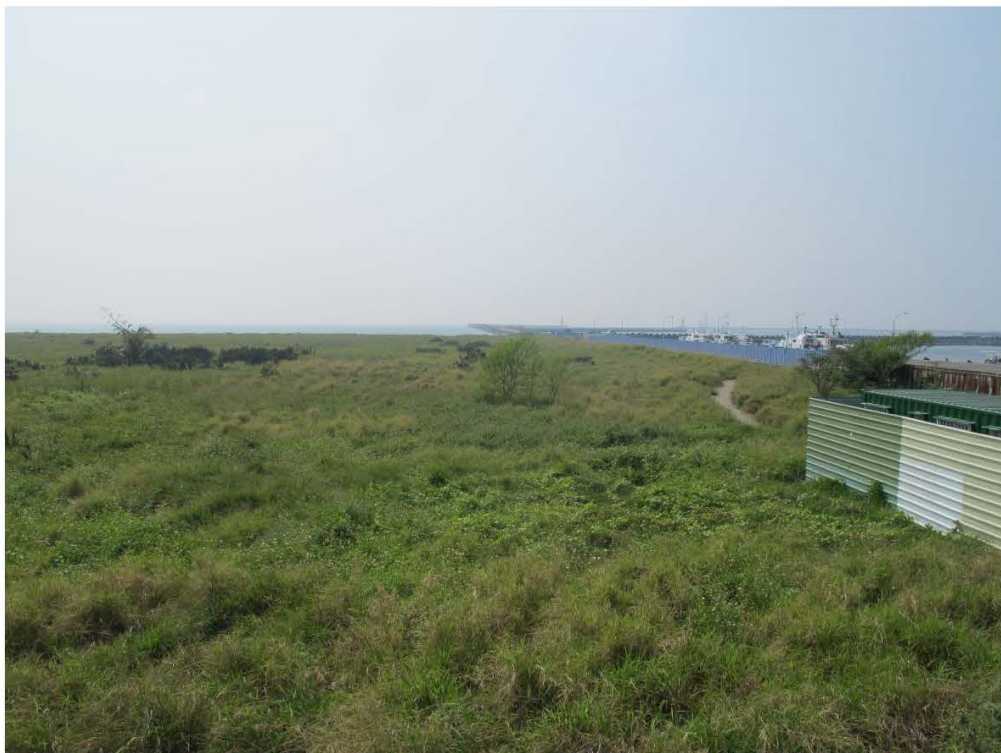
Finally, Photo 16 shows the accretion area immediately south of Anping Harbor. A large amount fine sand was deposited in this area because the port breakwater blocked northward longshore sand transport. In this accretion area, the shoreline has gradually advanced with maintaining the same berm height so that a very flat lowland was formed

Photo 16. Accreted area immediately south of Anping Harbor.

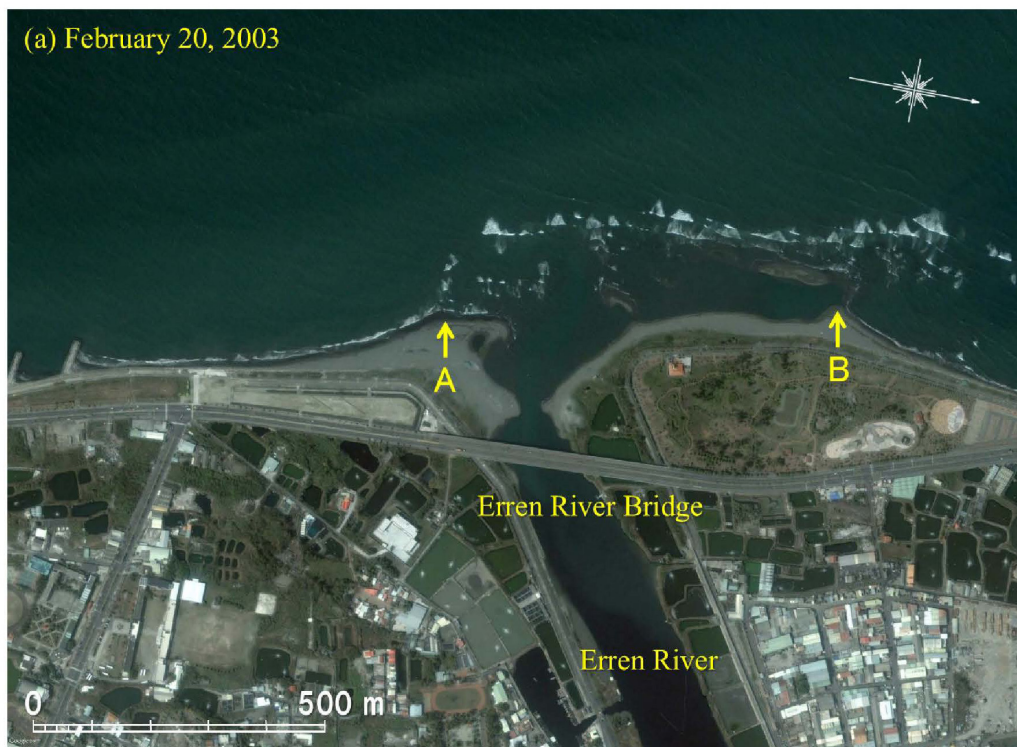
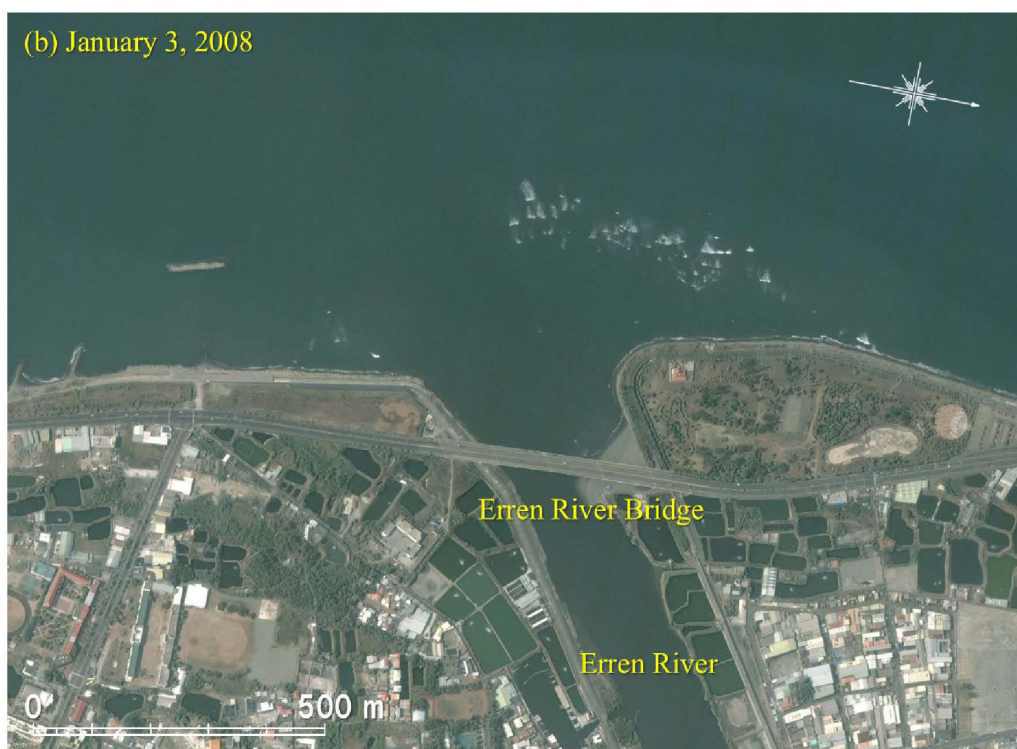
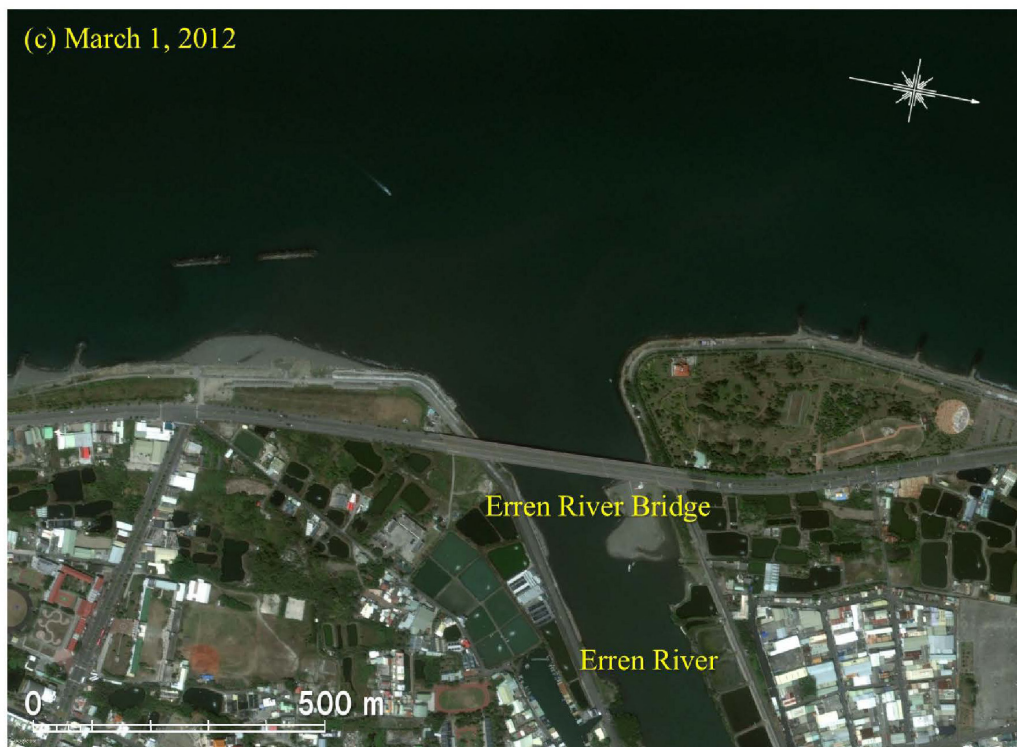
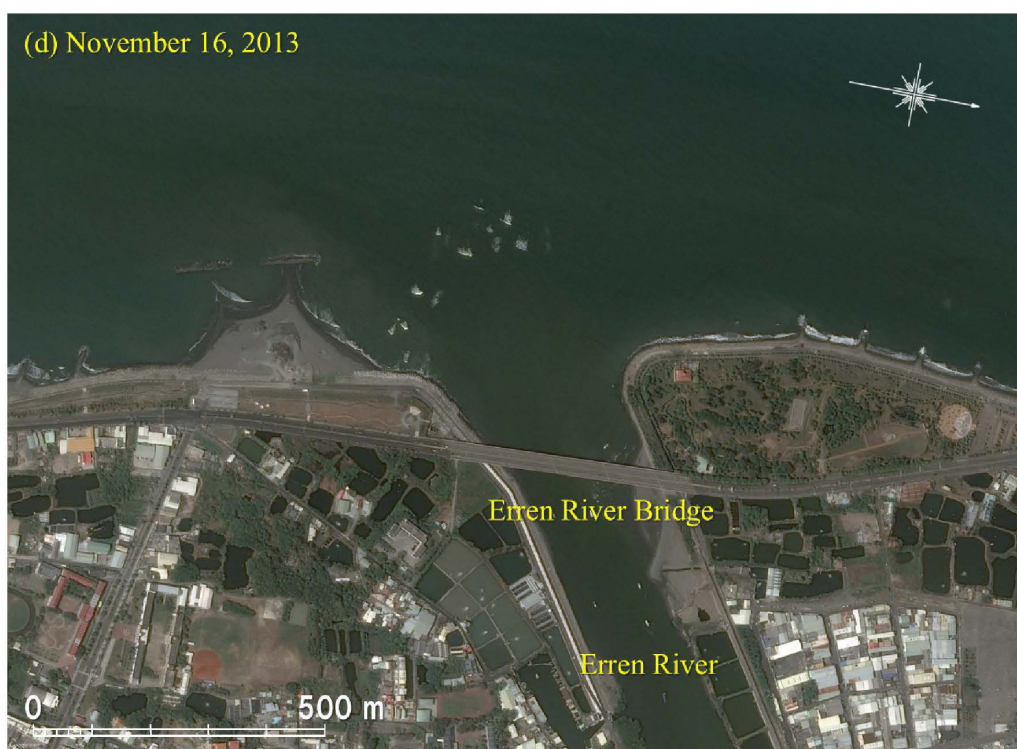
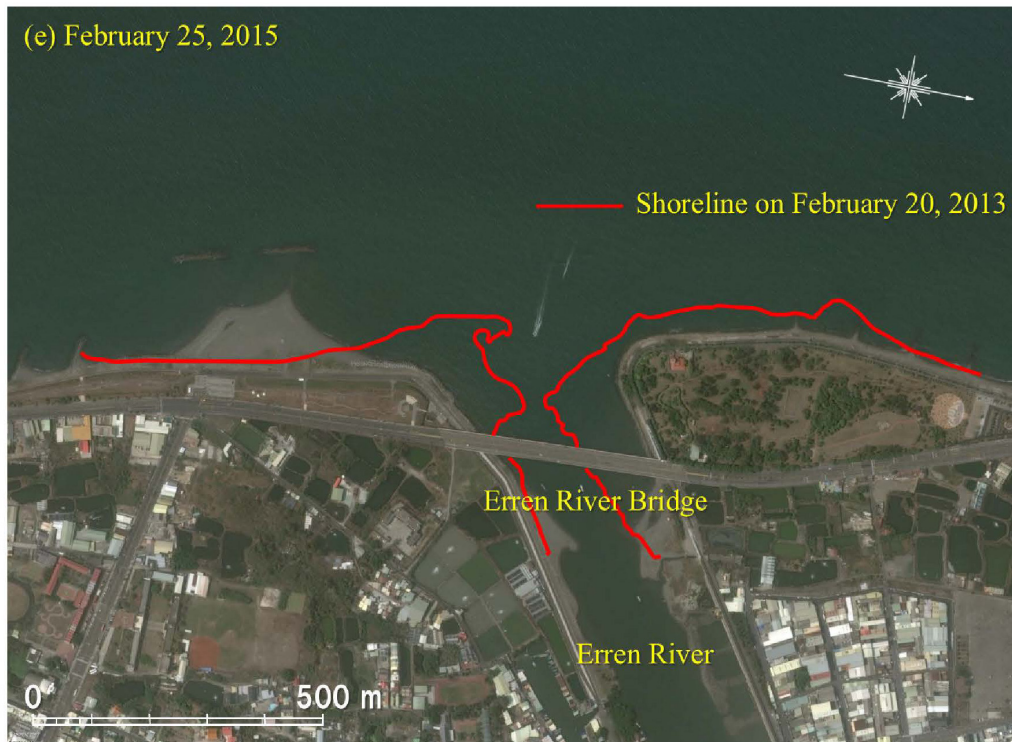
In Area I around the Erren River mouth, beach erosion occurred between 2003 and 2015, and a large amount sand discharged from this area. Although a large river mouth bar had been formed before February 20, 2003, it was eroded away up to February 25, 2015, resulting in exposure of both banks to waves. The cause is assumed to be imbalance of longshore sand transport, i.e., sand supply from the south coast decreased, whereas northward longshore sand transport prevailed in this area under the condition that the fluvial sand supply from the Erren River had decreased. In Area II immediately south of the river, where detached breakwaters had already constructed, at first sand was deposited behind the detached breakwaters but such sand was gradually transported away by northward sand transport, resulting that once-formed cusped forelands behind the detached breakwaters disappeared because of the permeable structure.

Fig. 2. Satellite images of Area I around Erren River mouth.

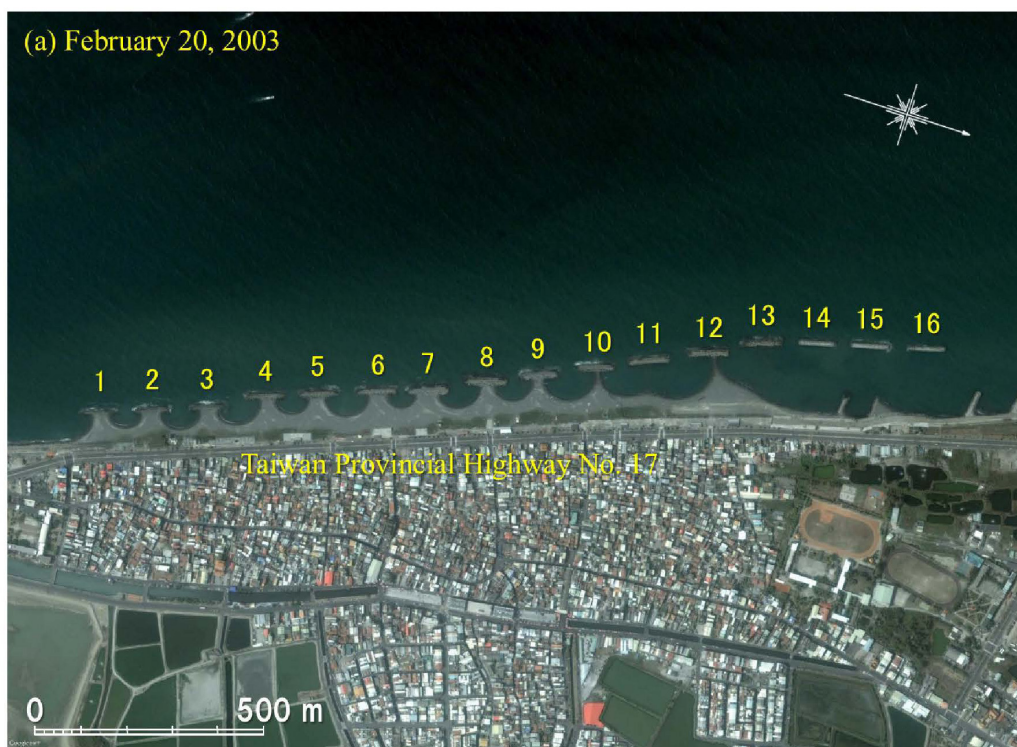
Fig. 3. Satellite images of Area II immediately south of Erren River mouth.
